Lovelace Property Inspection Services, Inc.

**Report #: 081806B
Subject Property**

**2608 S. Manhattan Ave.
Muncie, IN 47302**

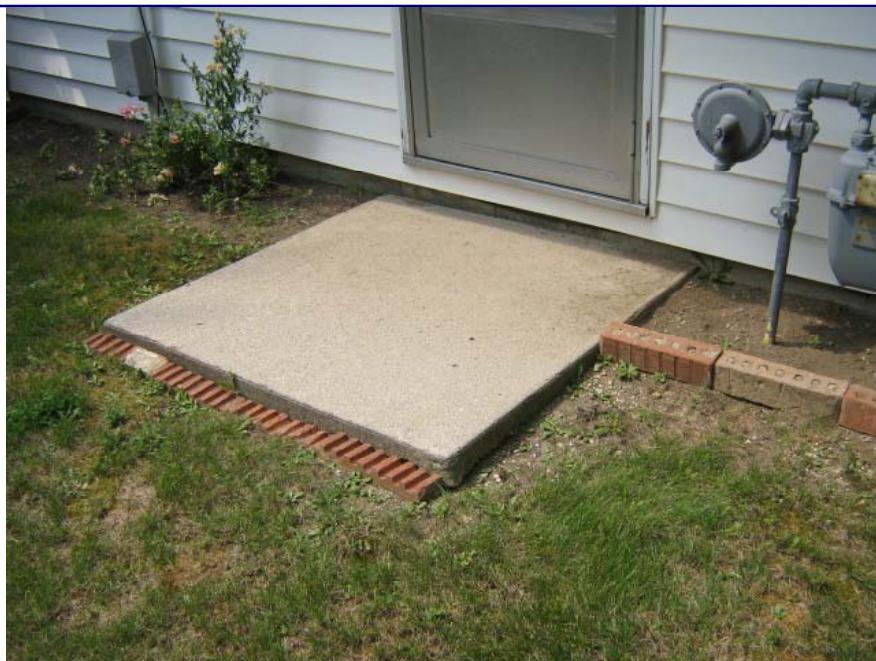
Picture 1

Rear porch has settled towards foundation.

Comments: Rear porch has settled towards foundation. SEE PHOTO 1.

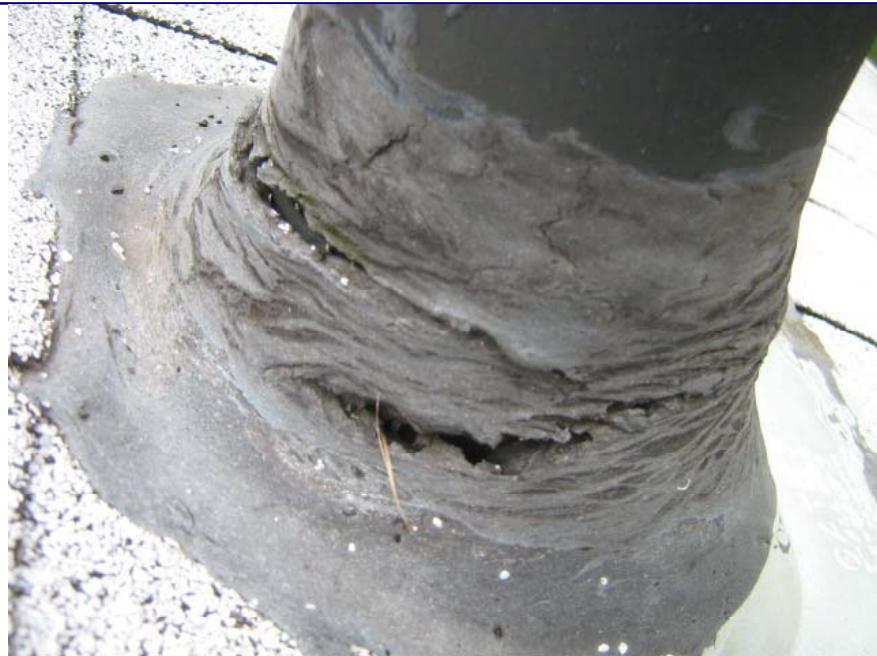
Picture 2

Roof penetrations have been mastic (tar) covered. One sewage vent appears to be cracked and may be leaking. Recommend repair to sewage vent boot to prevent leaking.

Comments: Roof penetrations have been mastic (tar) covered. One sewage vent appears to be cracked and may be leaking. Recommend repair to sewage vent boot to prevent leaking. SEE PHOTO 2.

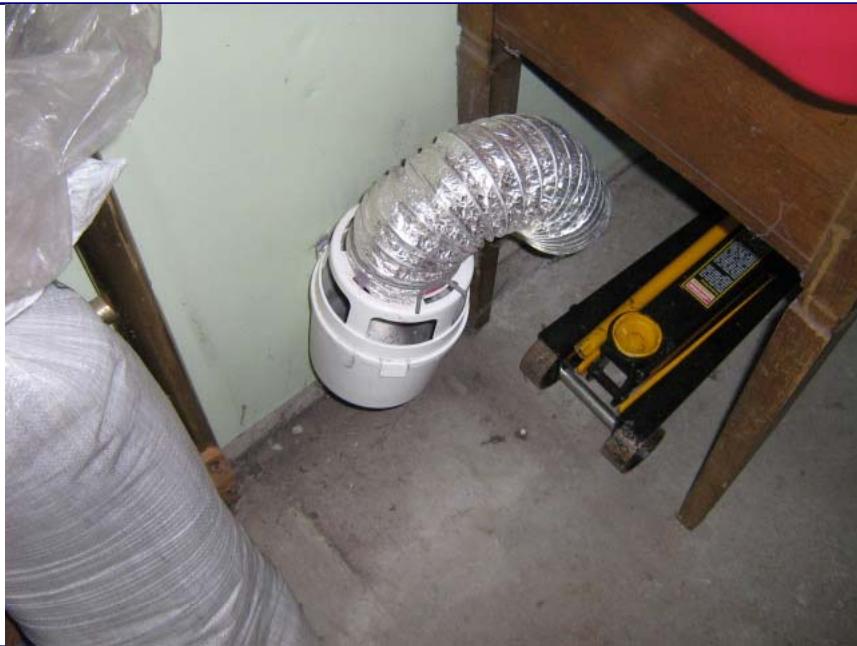
Picture 3

Clothes dryer is venting into garage. Hot, moist air has potential to cause some mold growth on garage walls, however no signs of mold / fungus growth at time of inspection.

Clothes dryer is venting into garage. Hot, moist air has potential to cause some mold growth on garage walls, however no

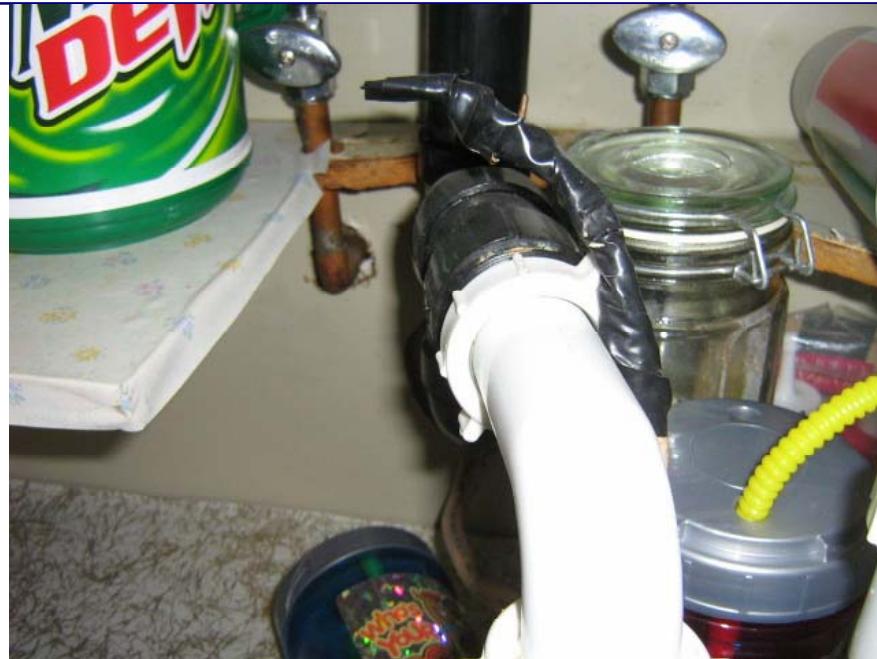
Picture 4

Exposed wire noted under kitchen for what appears to be removed garbage disposal. If disposal is not replaced, recommend protecting end of wire in junction box.

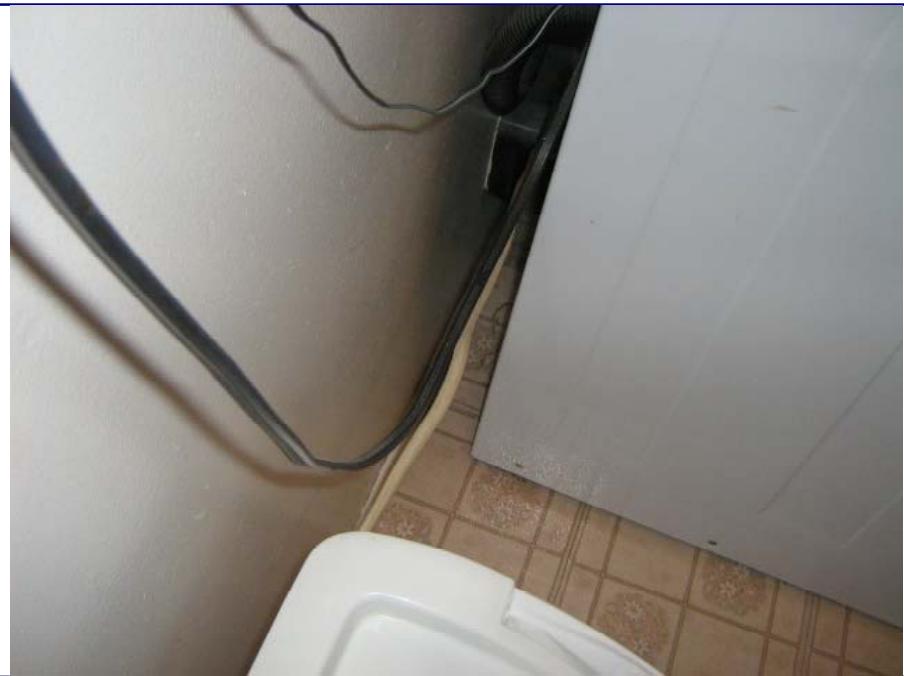
Picture 5

Dryer cord is connected to romex wire due to distance from outlet. Romex wire is susceptible to damage.

signs of mold / fungus growth at time of inspection. SEE PHOTO 3. Dryer cord is connected to romex wire due to distance from outlet. Romex wire is susceptible to damage. SEE PHOTO 5.

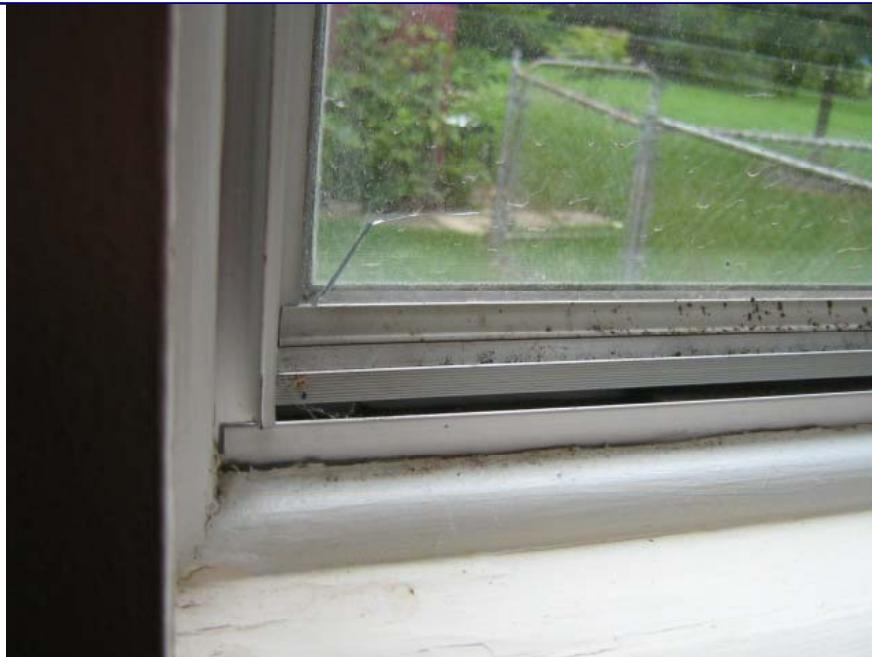
Picture 6

Minor crack noted at bedroom window.

Minor crack noted at bedroom window. SEE PHOTO 6.

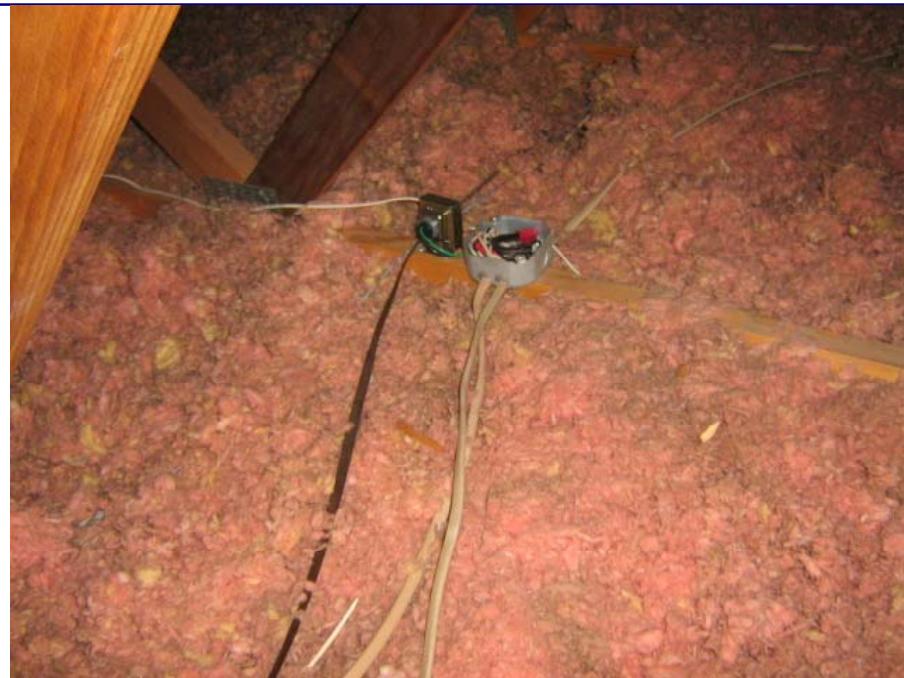
Picture 7

Junction box is missing cover plate noted in attic.
Recommend protecting open junction box with cover plate.

House has some older two conductor wiring with non-grounded two prong & three prong outlets. Junction box is missing cover plate noted in attic. Recommend protecting open junction box with cover plate. SEE PHOTO 7. Exposed wire noted under kitchen for what appears to be removed garbage disposal. SEE PHOTO 4.

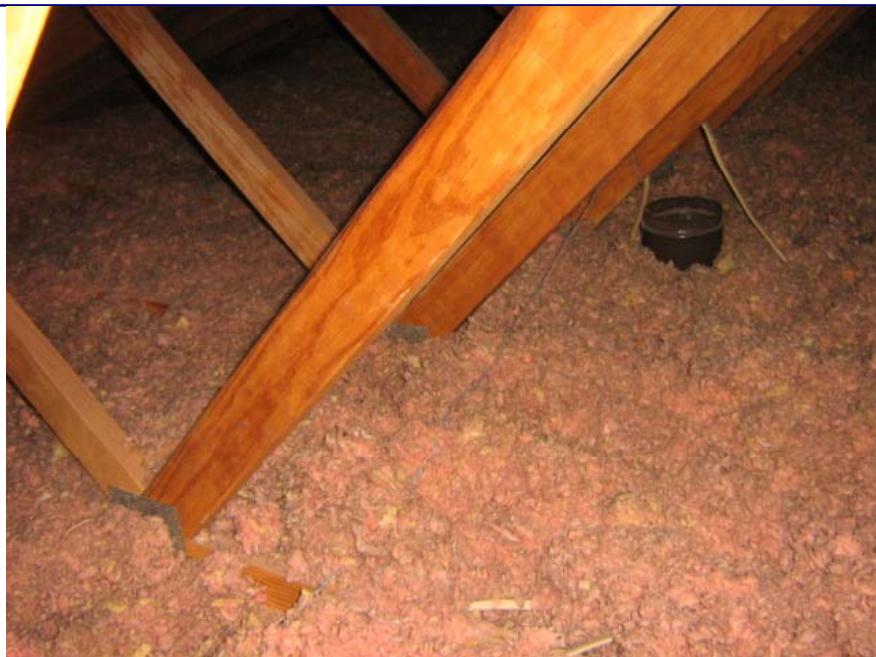
Picture 8

Bathroom exhaust fan is venting into attic. Recommend venting to exterior or near roof vent.

Bathroom exhaust fan is venting into attic. Recommend venting to exterior or near roof vent. SEE PHOTO 8. Soffit and gable vents noted.

Bathroom exhaust fan is venting into attic. Recommend venting to exterior or near roof vent. SEE PHOTO 8.

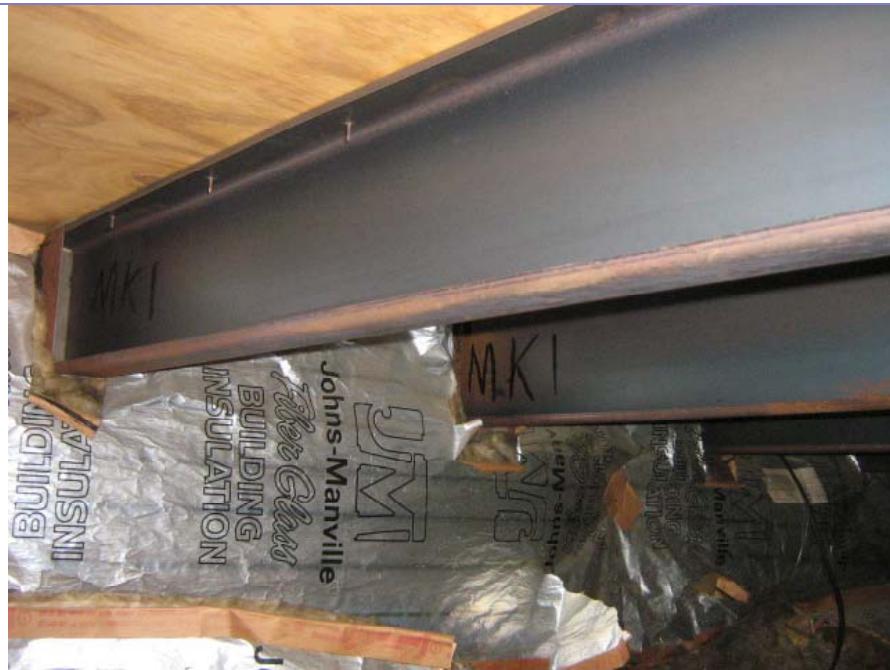
Picture 9

Floor joists and beam are made of steel and appeared serviceable at time of inspection. Unable to fully inspect foundation block due to insulation coverage.

Comments: Unable to fully inspect foundation block due to insulation coverage. SEE PHOTO 9. No crawlspace vents, crawlspace is sealed and conditioned to reduce moisture problems.

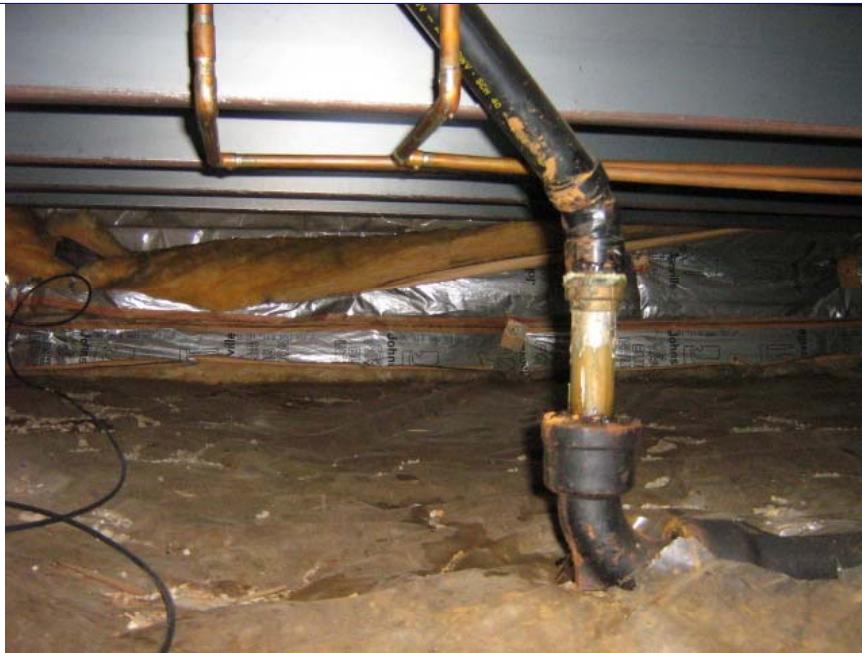
Picture 10

Plumbing waste lines are ABS (plastic), copper and cast iron. Some metal plumbing is showing minor rust and corrosion. No leaking noted to plumbing lines at time of inspection.

Comments: Plumbing waste lines are ABS (plastic), copper and cast iron. Some metal plumbing is showing minor rust and corrosion. No leaking noted to plumbing lines at time of inspection. SEE PHOTO 10.

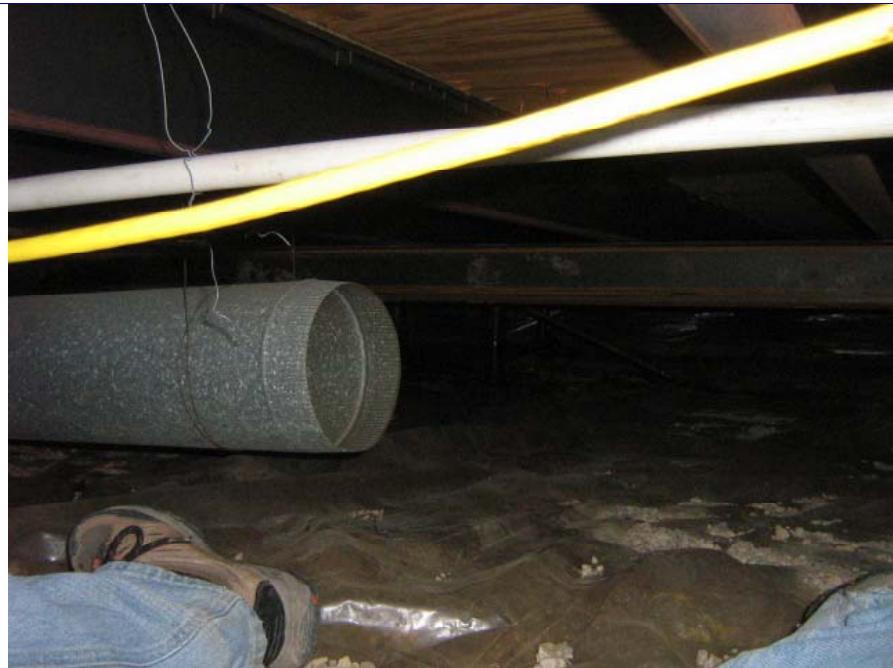
Picture 11

HVAC supply ducts are fed into crawlspace with no individual ducts connected to floor registers. This type duct system allows crawlspace to be conditioned and reduces potential moisture problems. Conditioned air rises through floor registers.

HVAC supply ducts are fed into crawlspace with no individual ducts connected to floor registers. This type duct system allows crawlspace to be conditioned and reduces potential moisture problems. Conditioned air rises through floor registers. SEE PHOTOS 11 & 12.

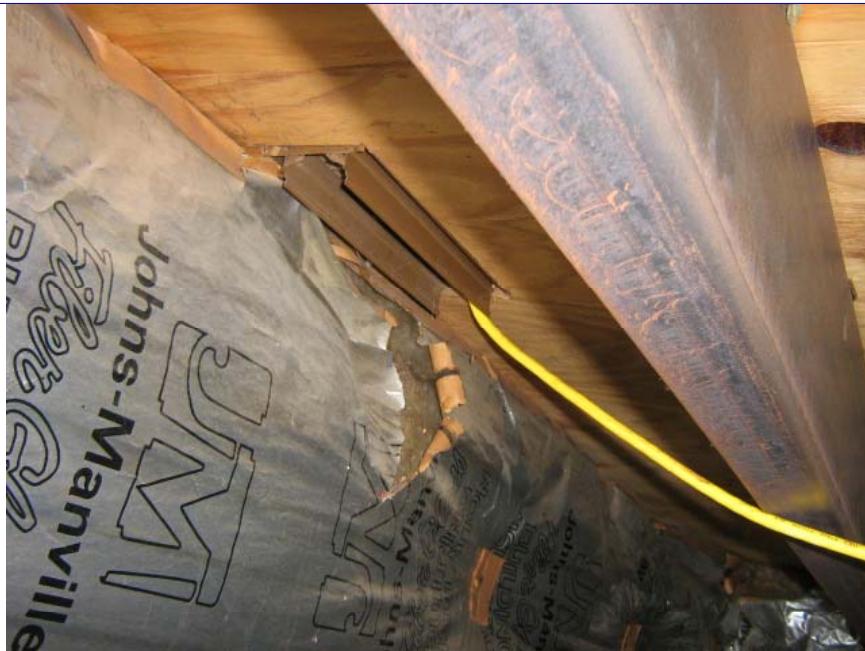
Picture 12

HVAC supply ducts are fed into crawlspace with no individual ducts connected to floor registers. This type duct system allows crawlspace to be conditioned and reduces potential moisture problems. Conditioned air rises through floor registers.
